Technical Report REMR-CS-53  
April 1997

*Repair, Evaluation, Maintenance, and Rehabilitation Research Program*

# **Applications of Roller-Compacted Concrete in Rehabilitation and Replacement of Hydraulic Structures**

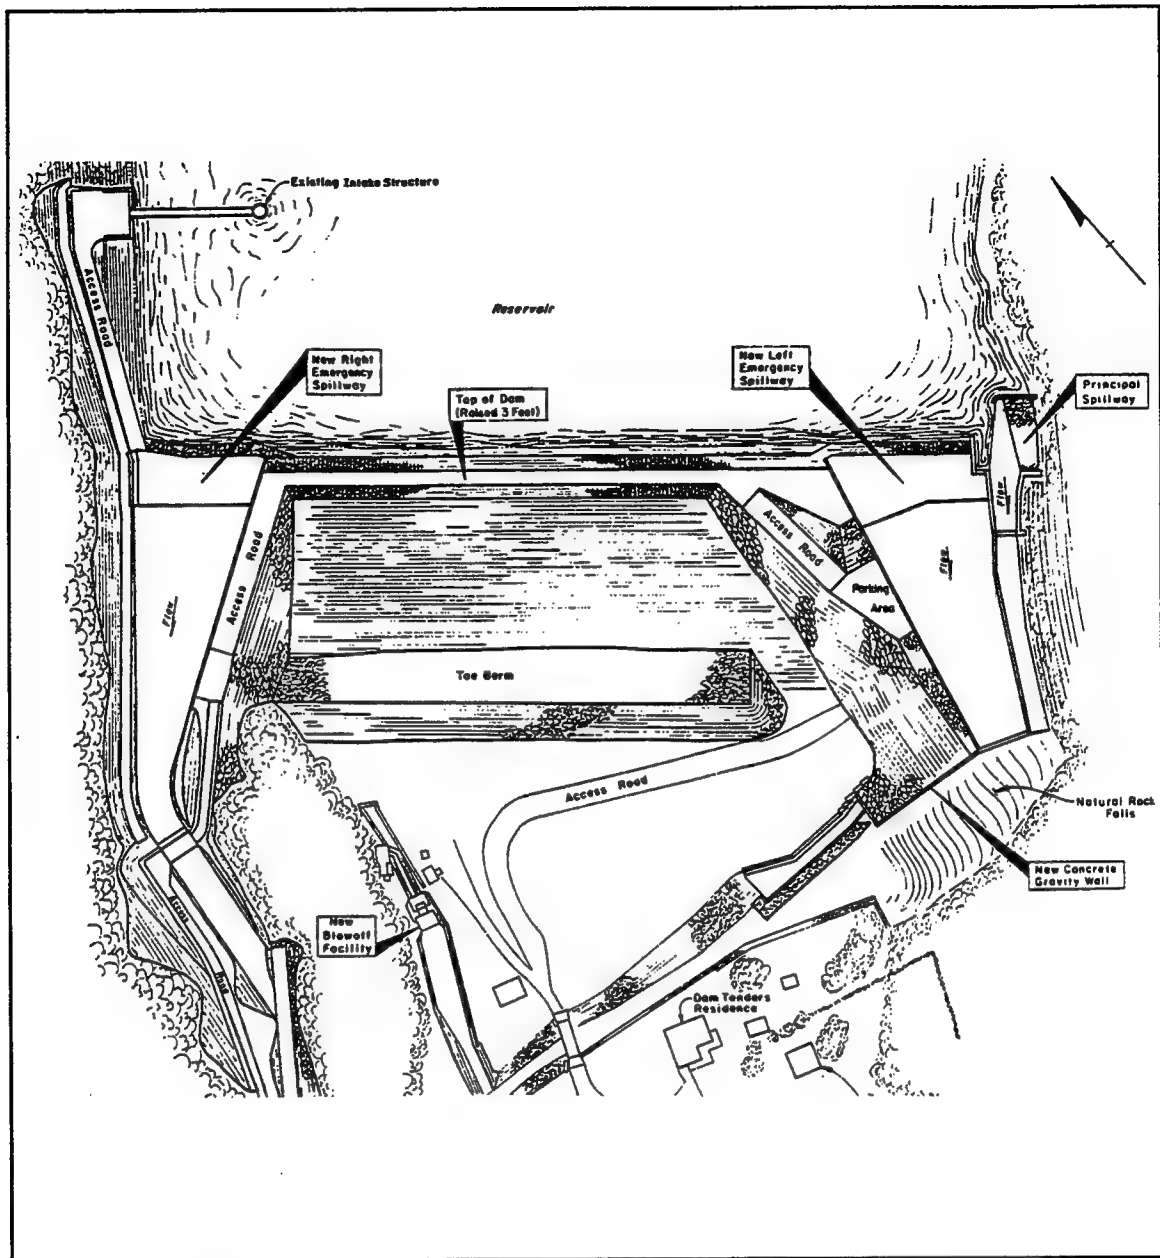
Figure 60. Modification plan for Saltlick Dam (courtesy of Bingham and Schweiger 1990, ASDSO). (Multiply feet by 0.3048 to obtain metres)

The dam withstood floods in 1936, 1972, 1975, and 1977 without serious structural damage. The maximum known flood occurred in 1977 and was estimated to have a maximum flow of 190 cms (6,700 cfs). During this flood, the earth embankment along the right concrete wall of the channel was eroded, and a small footbridge over the spillway was washed out. This damage was quickly repaired.

In June 1978, Saltlick Dam was judged to be unsafe nonemergency in the Phase I inspection of the National Dam Safety Program, and it was recommended that immediate studies be performed to determine the spillway capacity and the stability of the dam embankments. Subsequent studies were conducted by Gannett Fleming, Inc., in compliance with recommendations by the Commonwealth of Pennsylvania, Department of Environmental Resources (DER). It was concluded that (a) the existing spillway could handle only 37 percent of the PMF and that the spillway might be vulnerable to blockage from slides of potentially unstable material on the adjacent hillside, (b) the spillway and spillway channel needed repairs, (c) the stability of the downstream embankment was questionable, and (d) the blowoff equipment in the intake tower needed to be replaced. This case history is a summary of the project report by Bingham and Schweiger (1990).

The RCC alternative was chosen as it was more cost-effective than the 1983 plan and only slightly more costly than lowering the dam, which would have reduced reservoir capacity. The rehabilitation project consisted of raising the top of the dam 0.9 m (3 ft), constructing emergency spillways with RCC at the left and right abutments of the dam, lowering and repairing the existing concrete spillway, replacing the blowoff facilities, raising the intake tower, and enlarging the toe berm (Figure 60).

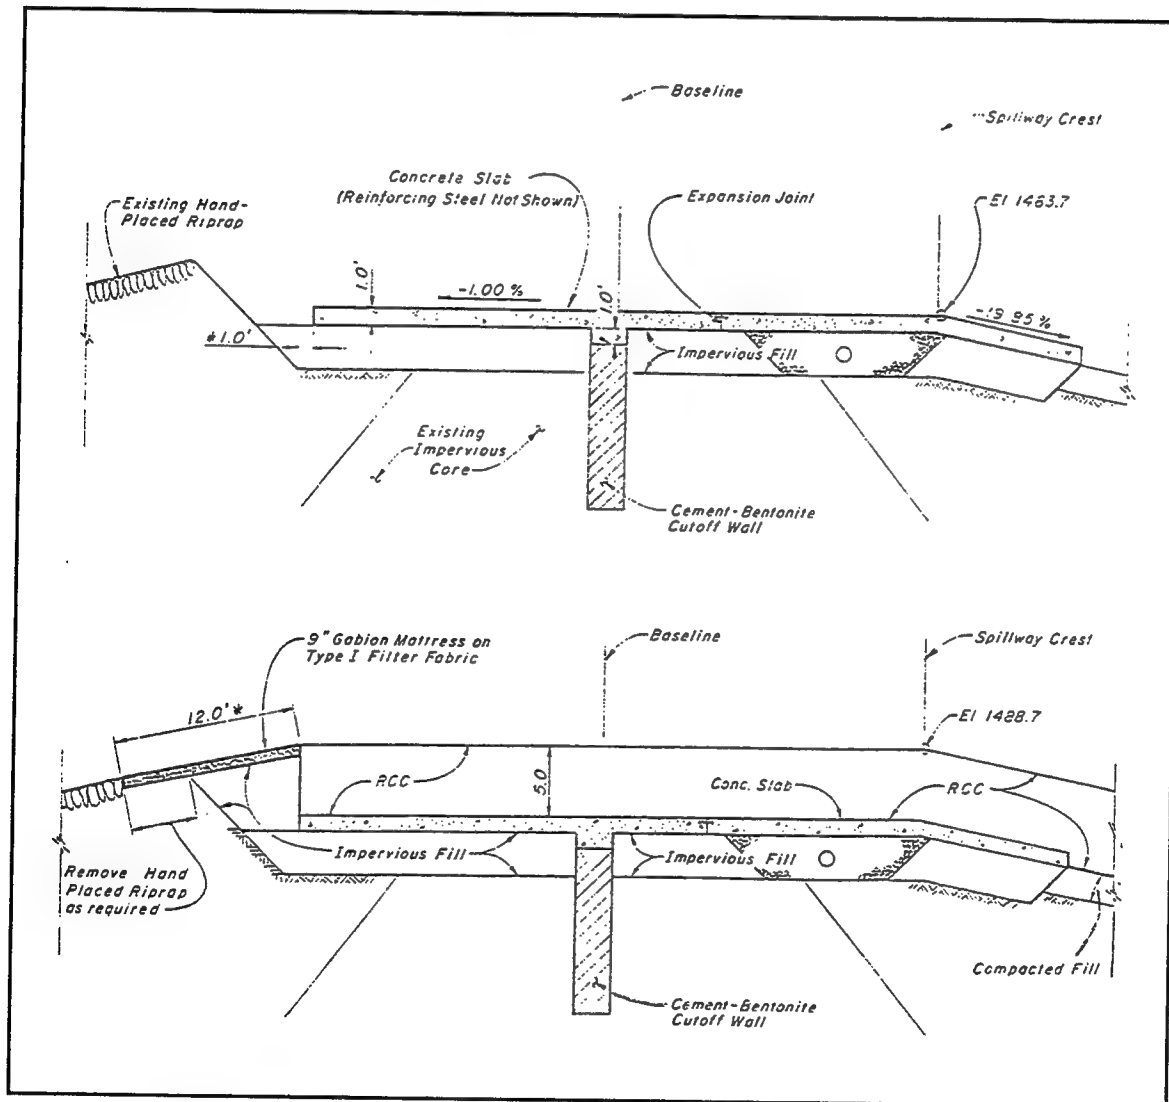
Figure 61. Spillway construction details at Saltlick Dam (courtesy of Bingham and Schweigher 1990, ASDSO). (Multiply inches by 25.4 to obtain millimetres and feet by 0.3048 to obtain metres)

A zone of highly permeable embankment material along the top of the dam was located during field investigations. The zone extended down to the hydraulic fill in some places; therefore, a decision was made to use a cement-bentonite slurry to construct an impervious cutoff between the core material and the raised top of the dam (Figure 61).

crane-operated shovel for excavating the embankment and to provide a foundation for the RCC that would allow for adequate compaction of the material. The base for the RCC slab consisted of a layer of heavy geotextile, covered with 0.9 m (3 ft) of specially blended impervious fill and then a 0.3-m- (1-ft-) thick slab of reinforced concrete.

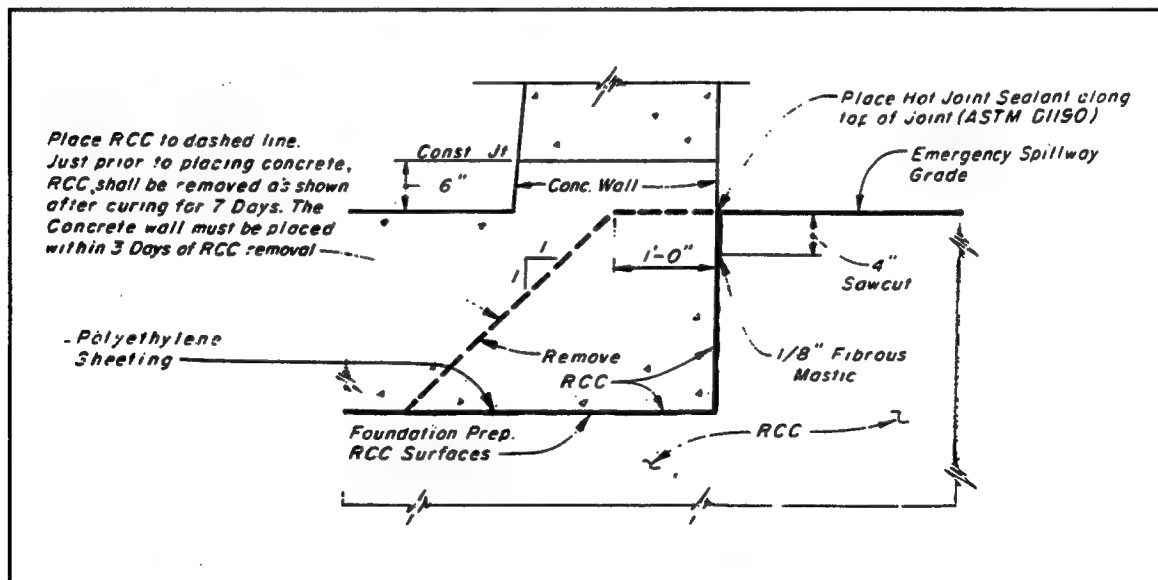
Figure 62. Detail showing RCC-concrete joint at Saltlick Dam (courtesy of Bingham and Schweiger 1990, ASDSO). (Multiply inches by 25.4 to obtain millimetres)

Obtaining good compaction of the RCC was sometimes difficult in areas where the RCC abutted an existing concrete structure. To fill voids that might occur in

these areas, a 0.6-m- (2-ft-) wide, 25-mm- (1-in.-) thick layer of bedding mixture was placed on the prepared foundation along the existing structure before the RCC was unloaded. When the RCC was spread and compacted, the bedding mixture squeezed up and against the abutting structure to form a bond.

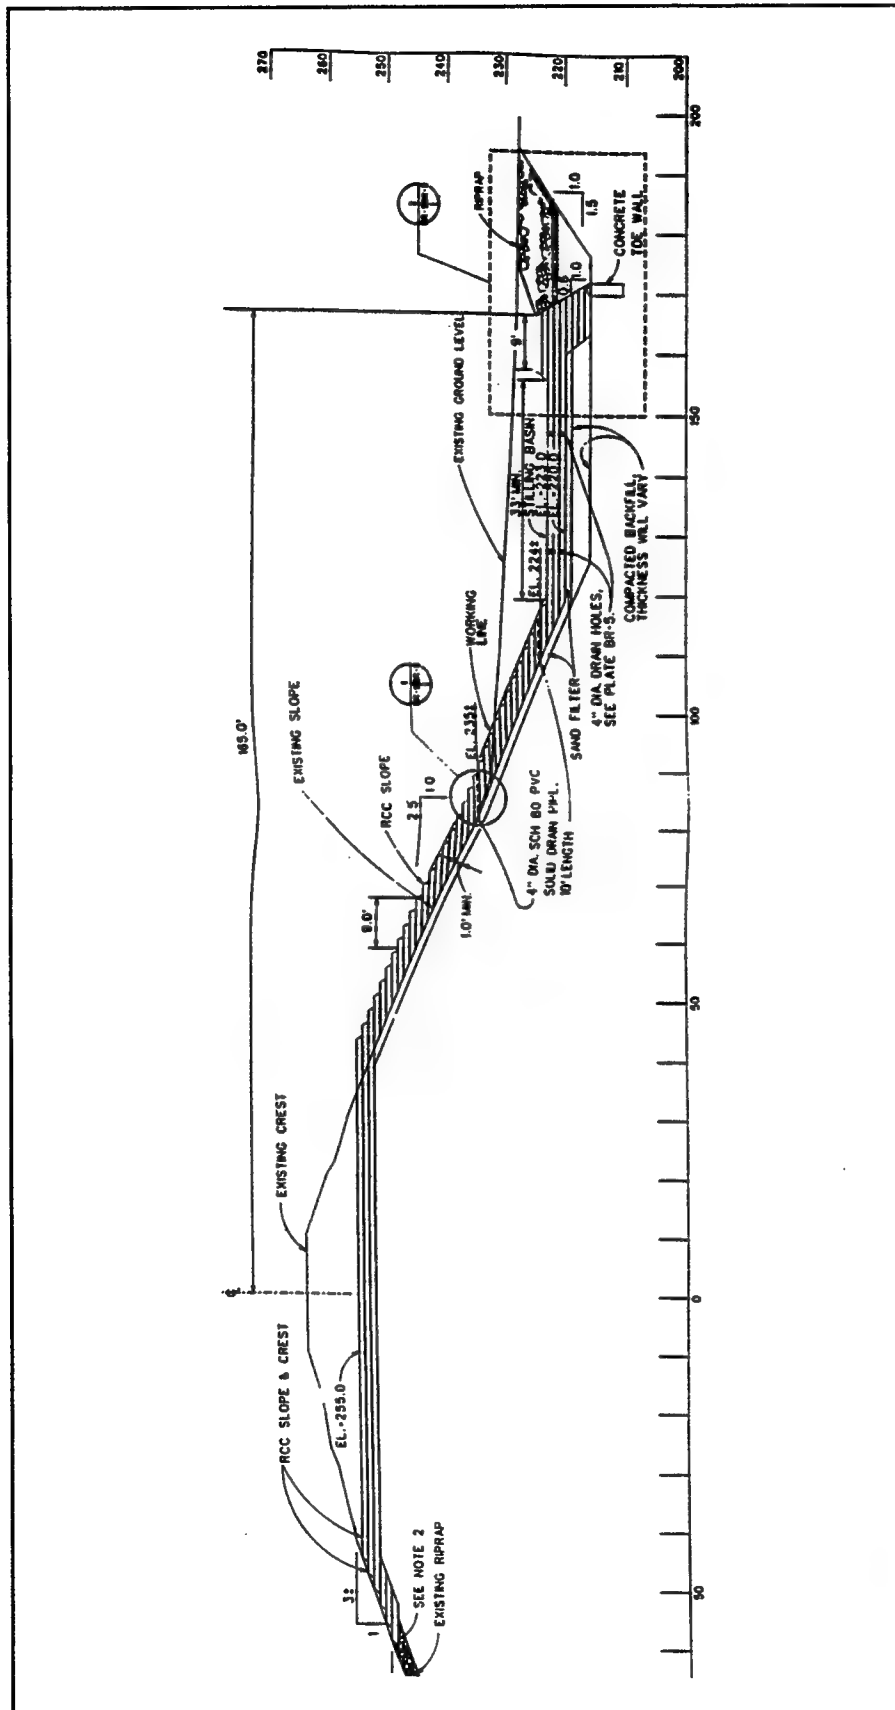
Figure 63. RCC modifications, Butler Reservoir Dam. (Multiply feet by 0.3048 to obtain metres)

In 1990, 17 dams overtopped at Fort Gordon near Augusta, GA. The U.S. Army Engineer District, Savannah, decided to rehabilitate some of them with RCC. At Butler Reservoir Dam, RCC was used to armor plate the crest and the upstream and downstream faces of the dam and in construction of a spillway (Figure 63). At Soil Erosion Dam, RCC will be used to construct a 54.9-m- (180-ft-) long saddle spillway and stilling basin and to protect the crest and downstream slope from erosion in the event of overtopping.

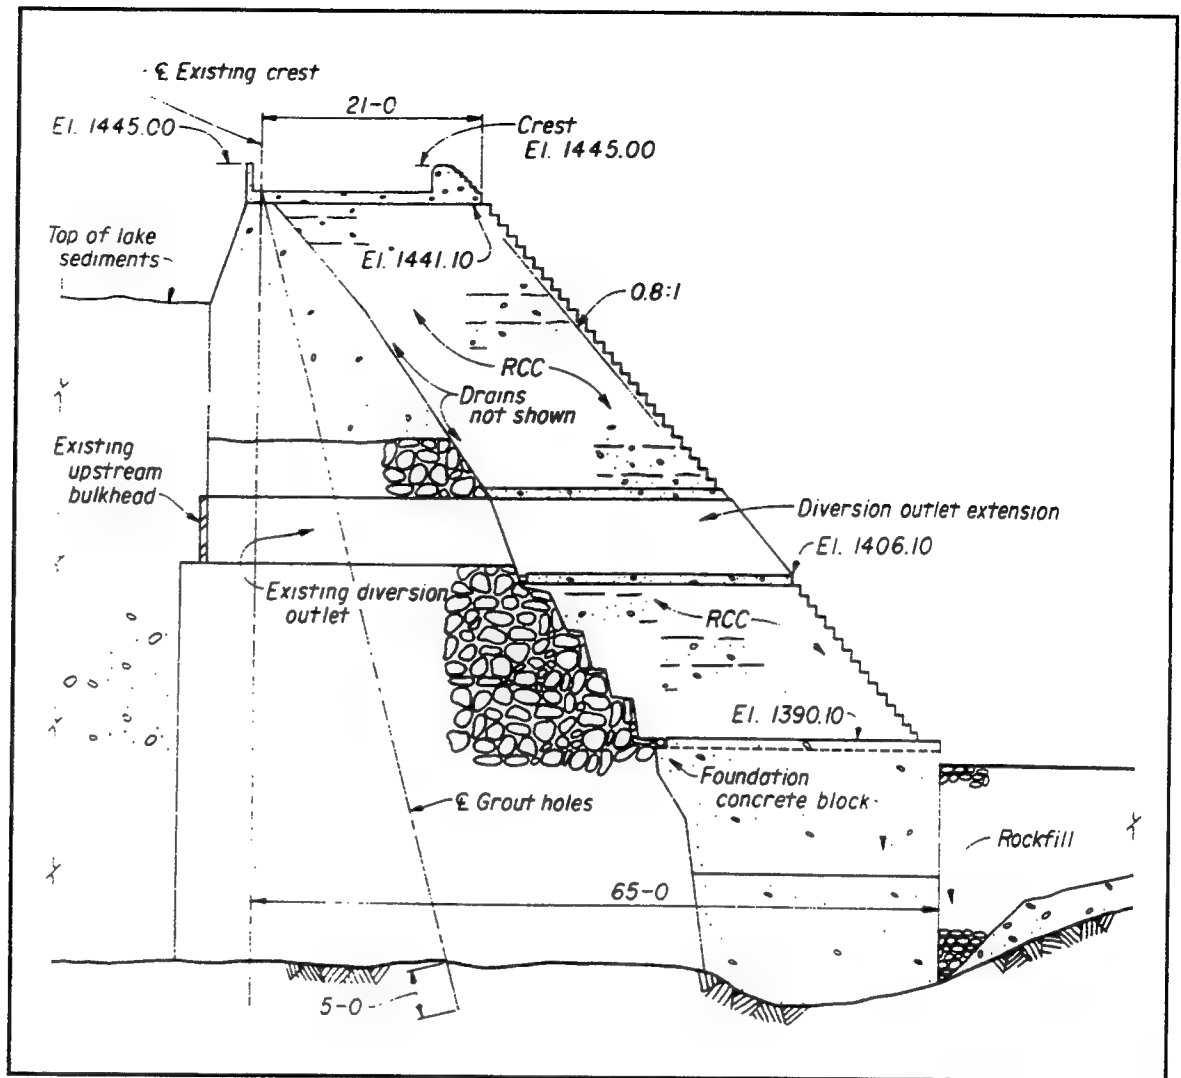
Figure 64. Cross section of modifications for Camp Dyer Division Dam (courtesy of Hepler 1992, ASDSO). (Multiply feet by 0.3048 to obtain metres)

Static and dynamic stability analyses were performed on the maximum section of the existing dam. The results showed that compressive stresses were within acceptable limits, and there were no tensile stresses for all loading conditions. However, the estimated factors of safety for sliding stability did not meet USBR criteria. To increase the dead load and the sliding resistance of the structure, a buttress was designed for the downstream face of the existing dam. USBR elected to use RCC for construction of the buttress rather than conventional concrete because of its relative economy and ease of construction.

The original design for the buttress specified a 4.6-m (15-ft) width and a downstream slope of 8H:1V. However, for final design the width was increased to 6.1 m (20 ft) to accommodate two lanes of traffic for the RCC lifts. A foundation concrete block was added to the maximum section below el 423.7 m (1,390.1 ft) within the river channel. The concrete block provided a longer and more uniform foundation for the RCC and reduced the overall amount of concrete required (Figure 64).

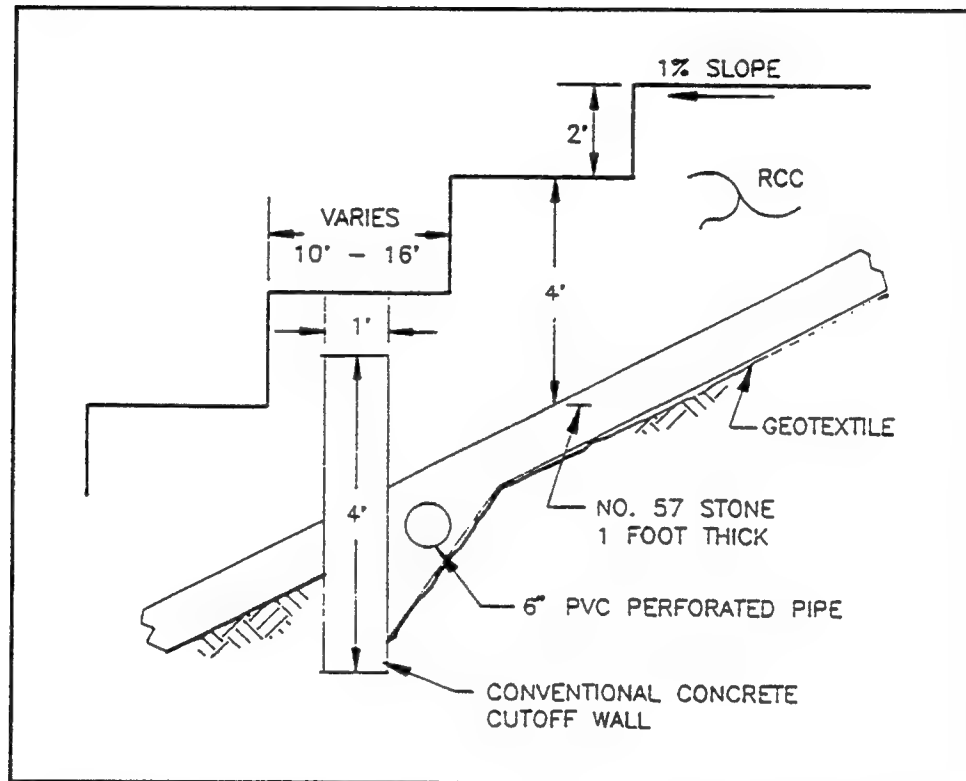
An analysis of various spillway materials showed that RCC would be the most economical choice. The RCC was to be placed in a stepped profile on the 5:1 channel slope to help aerate the water and dissipate energy (Figure 68). The completed spillway would have a 30.5-m- (100-ft-) wide control section that would narrow to 18.3 m (60 ft) at the base. The RCC would be thick enough to resist the maximum potential uplift forces, and an underdrain system would collect seepage beneath the spillway.

Figure 68. Cross section of RCC spillway design for North Potato Creek Dam (courtesy of Bass 1992, ASDSO). (Multiply inches by 25.4 to obtain millimetres and feet by 0.3048 to obtain metres)

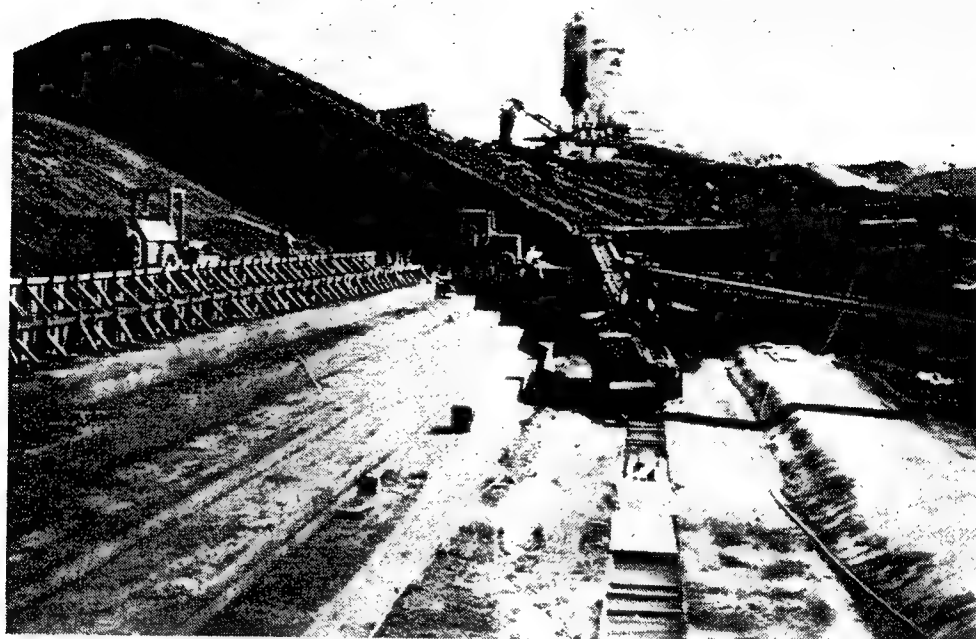
Figure 70. RCC placement operations, Ponca Dam spillway (courtesy of Calvino 1993)

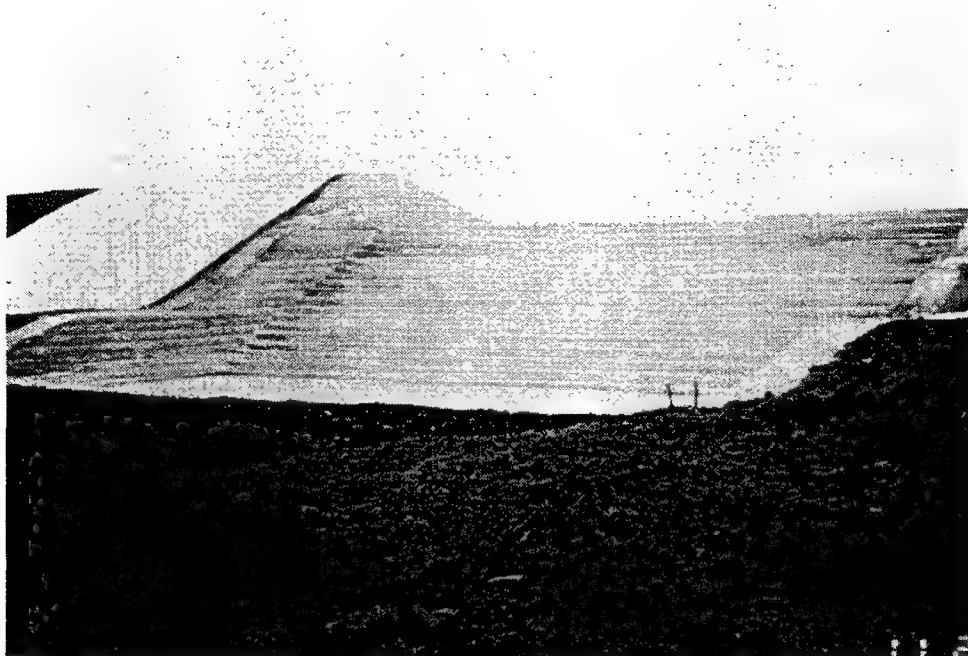
Joints were also placed parallel to the direction of flow to minimize the potential for shrinkage cracking in the spillway chute. Joints were formed next to the training walls to allow the slab to shrink away from the rigid RCC walls. However, some minor shrinkage cracks did develop about 1 month after

completion of the RCC placement. The completed spillway is shown in Figure 71.

Figure 71. Completed spillway, Ponca Dam (courtesy of Calvino 1993)

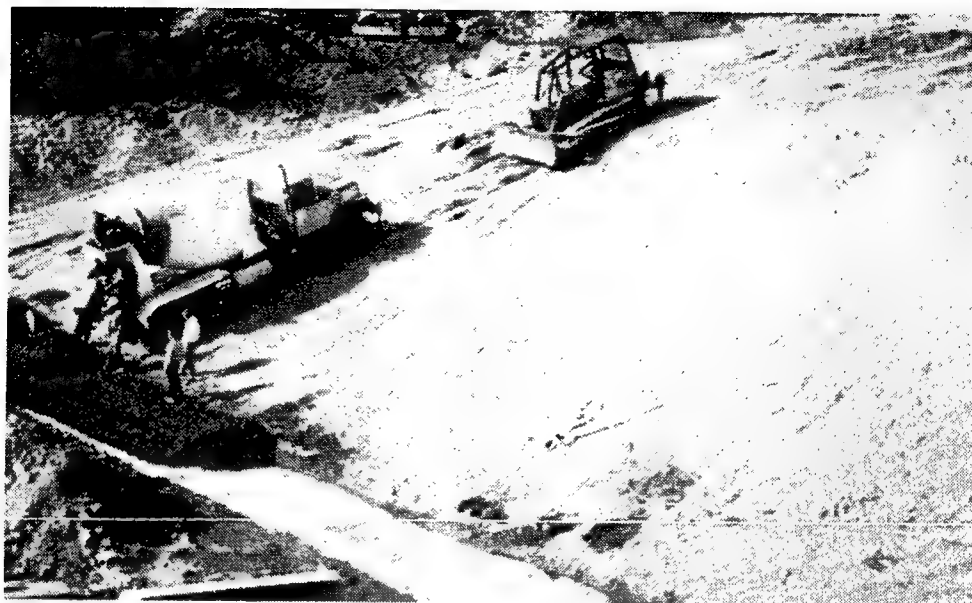
Initially, the trucks attempted to discharge the RCC on level ground; however, when it became apparent the trucks needed to be on a slope to expedite discharging, earth ramps were constructed along the top of the dam, and the RCC was discharged into the hopper of a mobile conveyor that transported it to the placement site. Two trucks were able to discharge onto the conveyor simultaneously. Along the left abutment, trucks could back down the 5H:1V slope and discharge directly onto the placement area (Figure 73). Discharging a truck took about 8 min on the ramps and 5 min on the left abutment (Calvino 1993). Following placement, the RCC was spread with a dozer and rolled.

**Figure 73. RCC being discharged from ready-mix truck onto left abutment at Rosebud Dam (courtesy of Calvino 1993)**

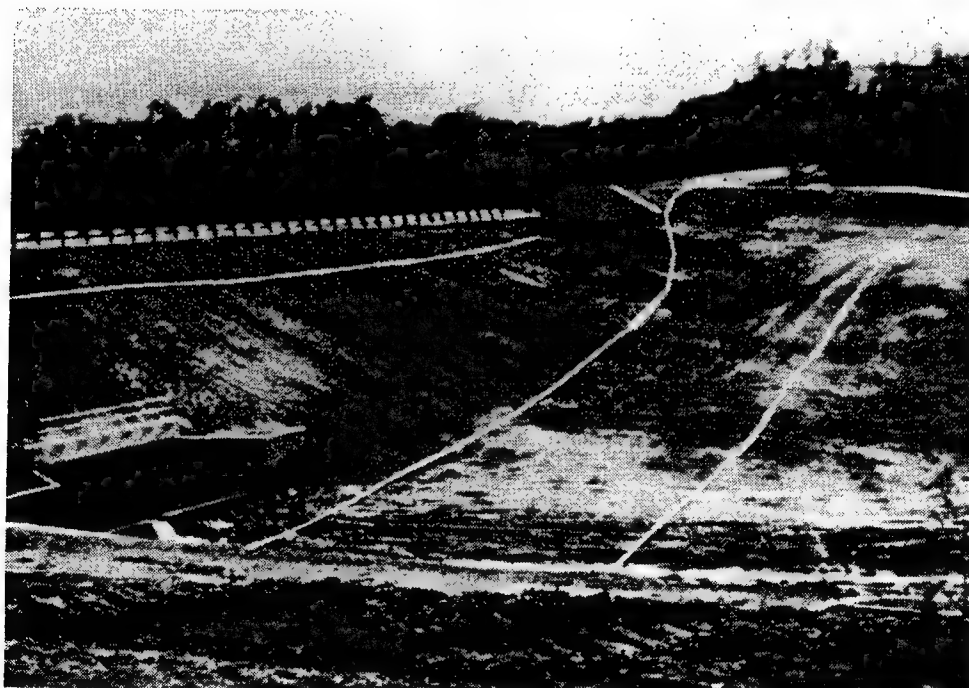
The RCC was placed in a stepped configuration in 0.3-m- (1-ft-) thick lifts. The lifts were 2.4 m (8 ft) wide on the 2H:1V slope of the embankment, 3.7 m (12 ft) wide on the 3.5H:1V slope of the downstream right abutment, and 4.6 m (15 ft) wide on the 5H:1V slope of the downstream left abutment. Minimum concrete thickness perpendicular to the slope was 0.6 m (2 ft). The edges of the RCC lifts were not formed or compacted. The contractor was able to place RCC at a peak rate of 65 cu m (85 cu yd) per hr and averaged placing about 54 cu m (70 cu yd) per hr over an entire day. The average daily placement was about 382 cu m (500 cu yd) with a maximum of 554 cu m (724 cu yd). A total of 3,600 cu m (4,700 cu yd) of RCC was placed at a cost of \$100.24/cu m (\$76.64/cu yd), including materials and placement (Calvino 1993). The final RCC surface was covered with 457 mm (18 in.) of topsoil and seeded to provide protection from freezing and thawing and to make the dam blend with its surroundings (Figure 74).

**Figure 74. Seeded topsoil placed over RCC overtopping protection at Rosebud Dam (courtesy of Calvino 1993)**

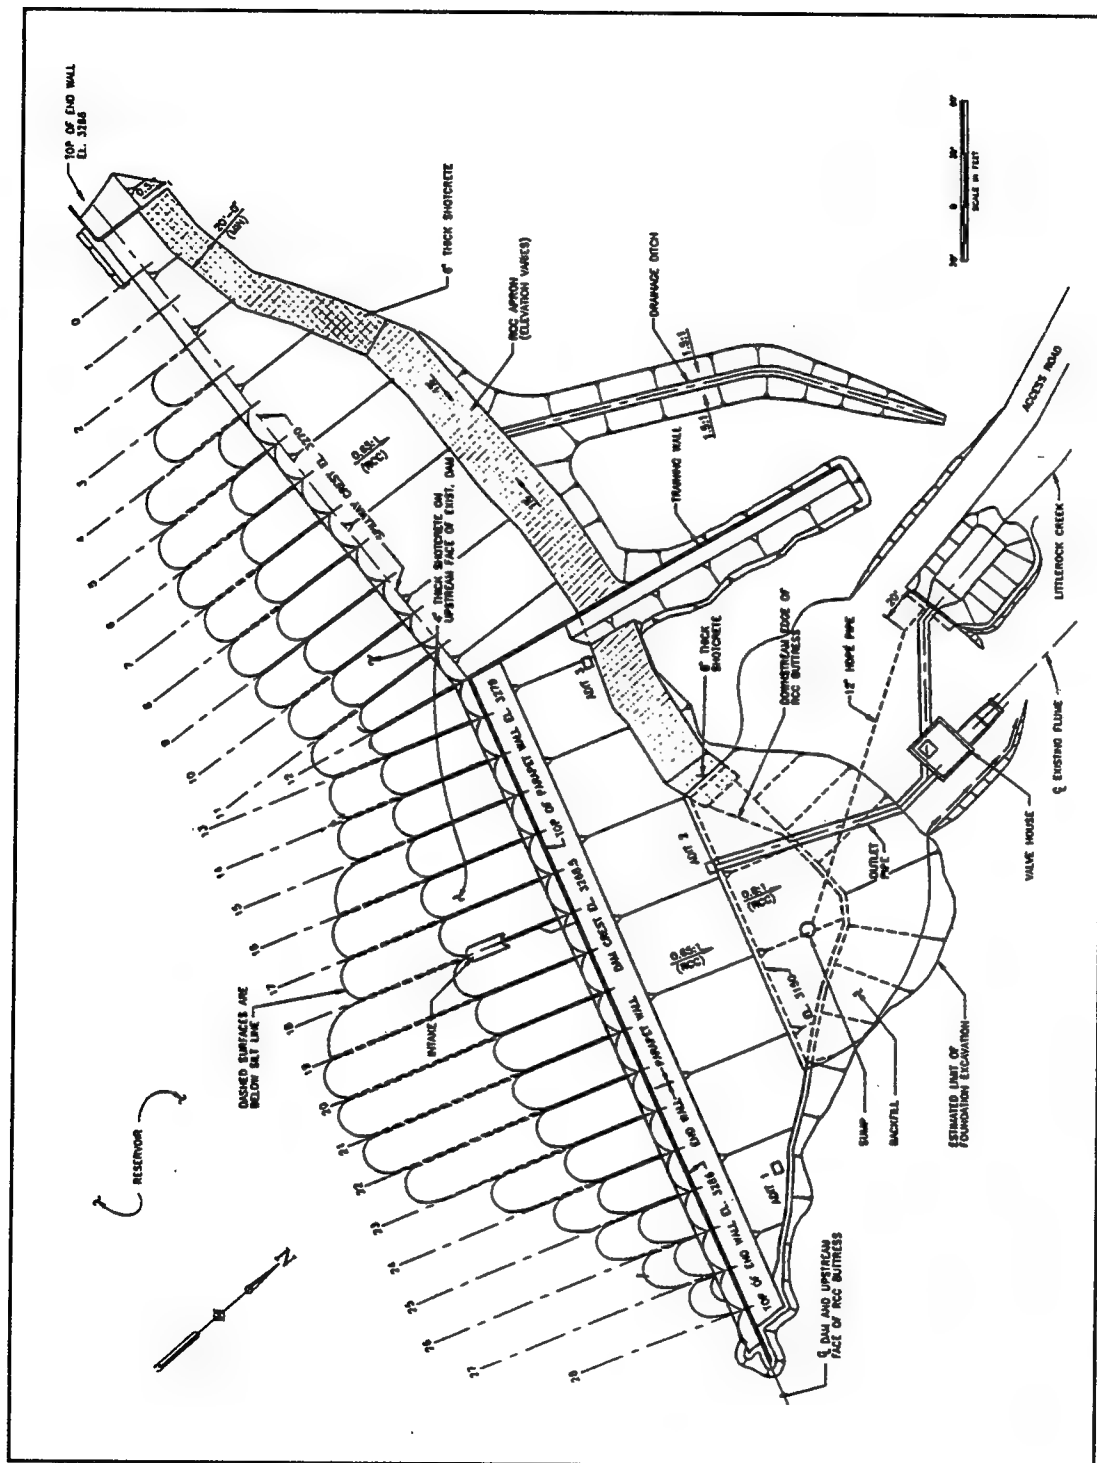
An overview of the rehabilitation plan is shown in Figure 75. The nonoverflow section of the dam would be raised to a height of about 58 m (190 ft) (Figures 76 and 77). The spillway crest would be raised about 3.7 m (12 ft) (Figures 78 and 79), which would increase reservoir capacity to 4,317,000 cu m (3,500 acre-ft). The total volume of the buttress would be 90,220 cu m (118,000 cu yd), including 80,300 cu m (105,000 cu yd) of RCC.

Figure 75. Rehabilitation plan for Little Rock Dam (courtesy of Wong, Forrest, and Lo 1993, ASDSO)

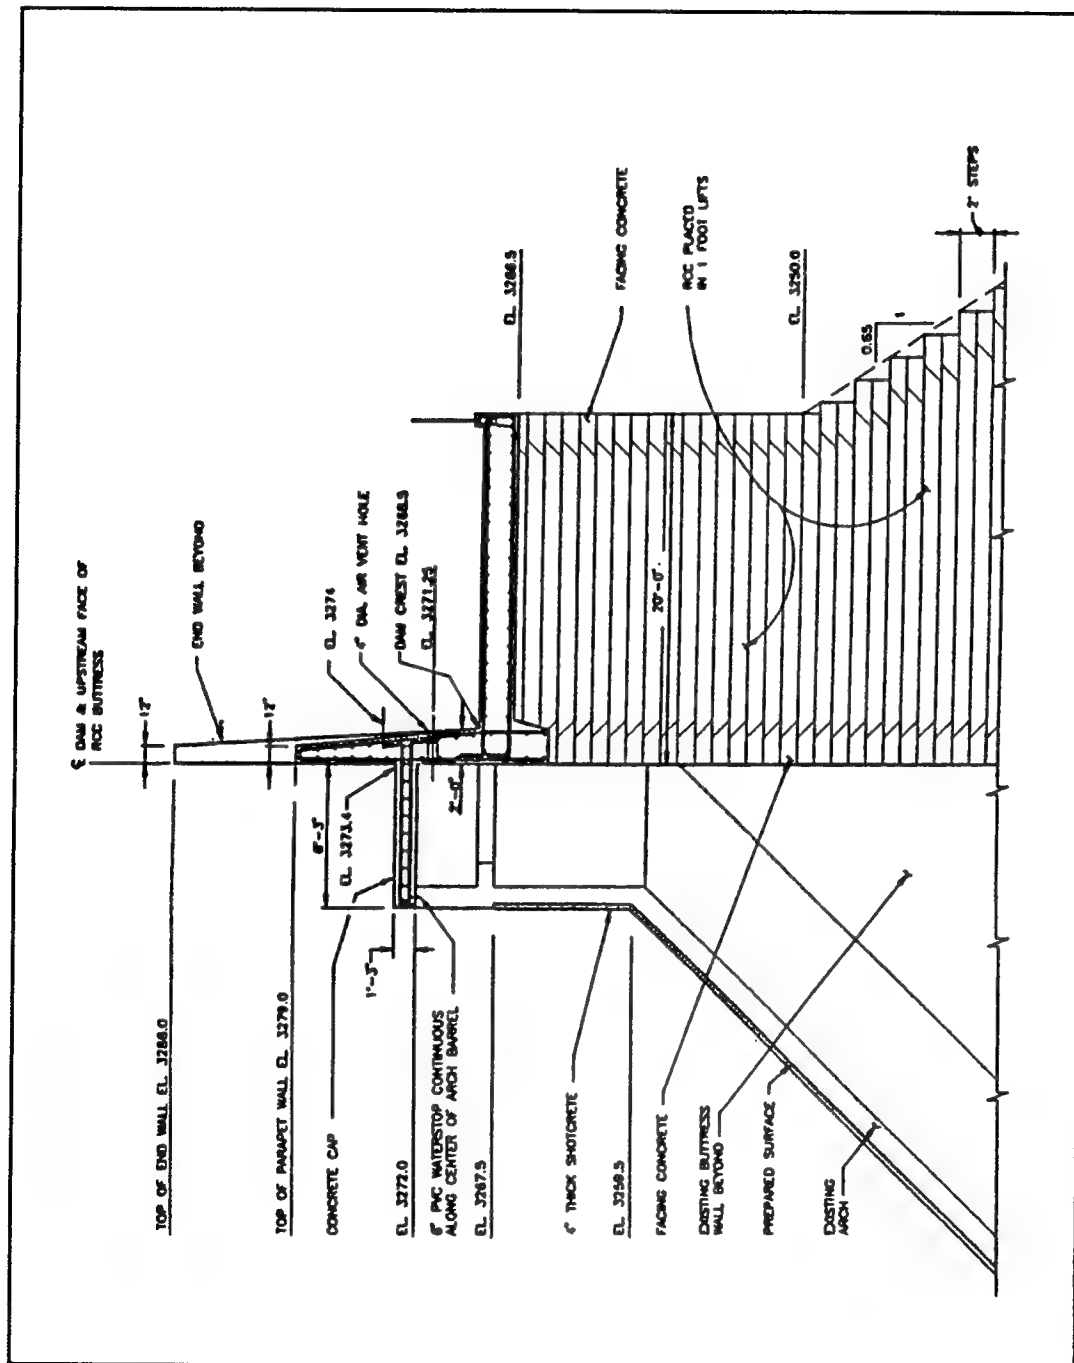
Figure 77. Crest detail, nonoverflow section, Little Rock Dam (courtesy of Wong, Forrest, and Lo 1993, ASDSO). (Multiply feet by 0.3048 to obtain metres and inches by 25.4 to obtain millimetres)

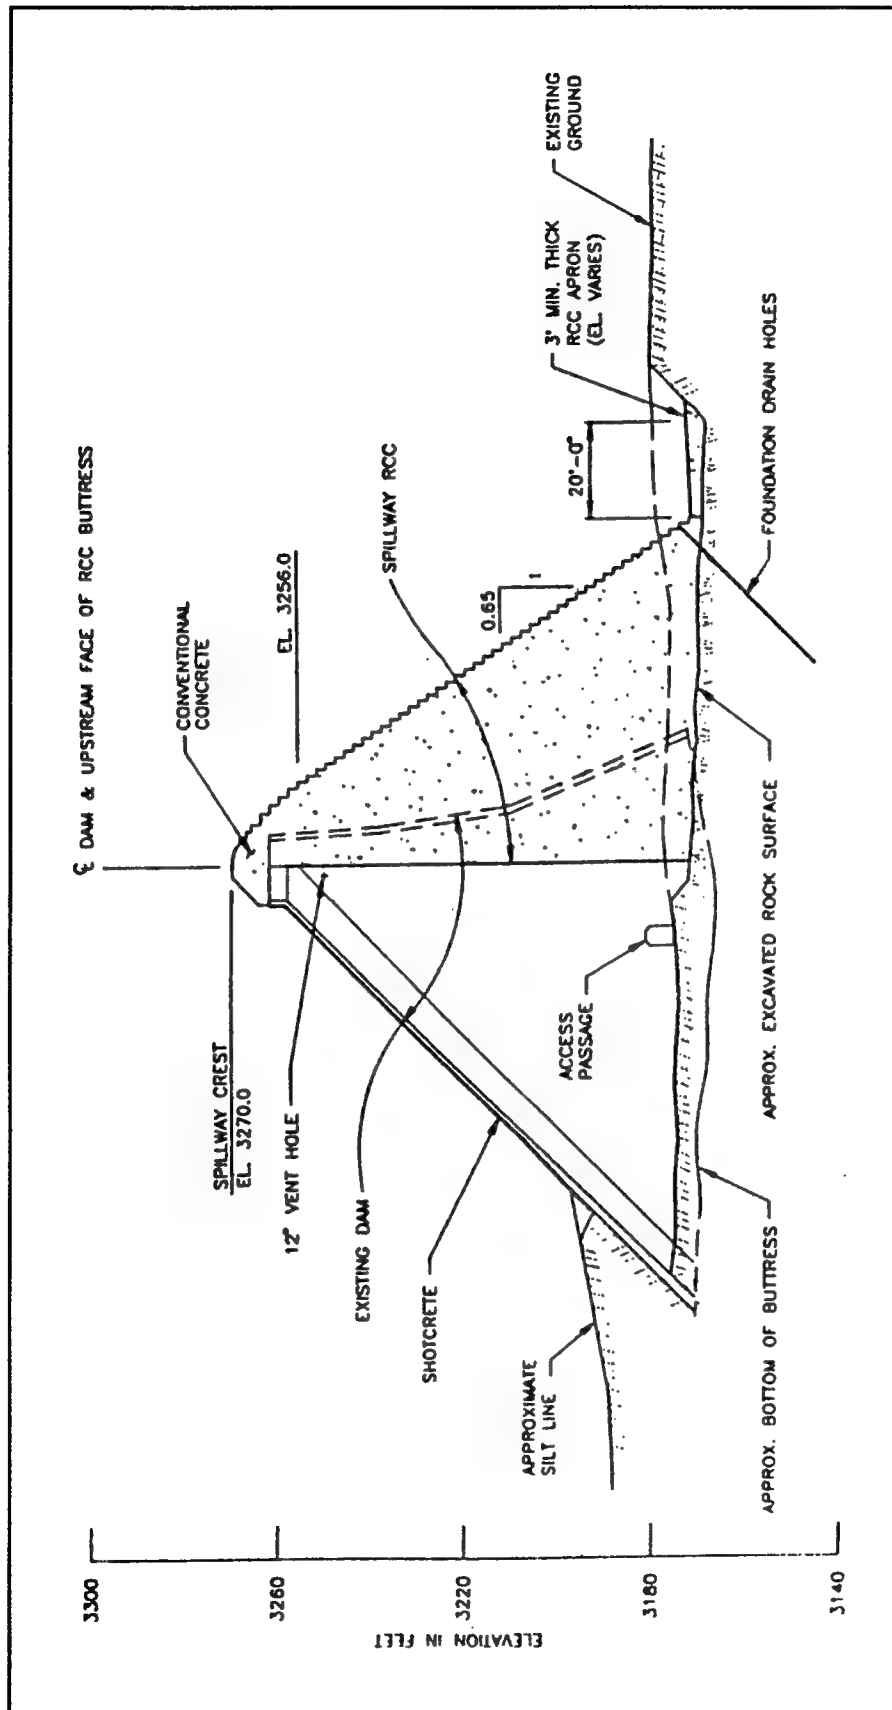
Figure 78. Spillway section, Little Rock Dam (courtesy of Wong, Forrest, and Lo 1993, ASDSO)

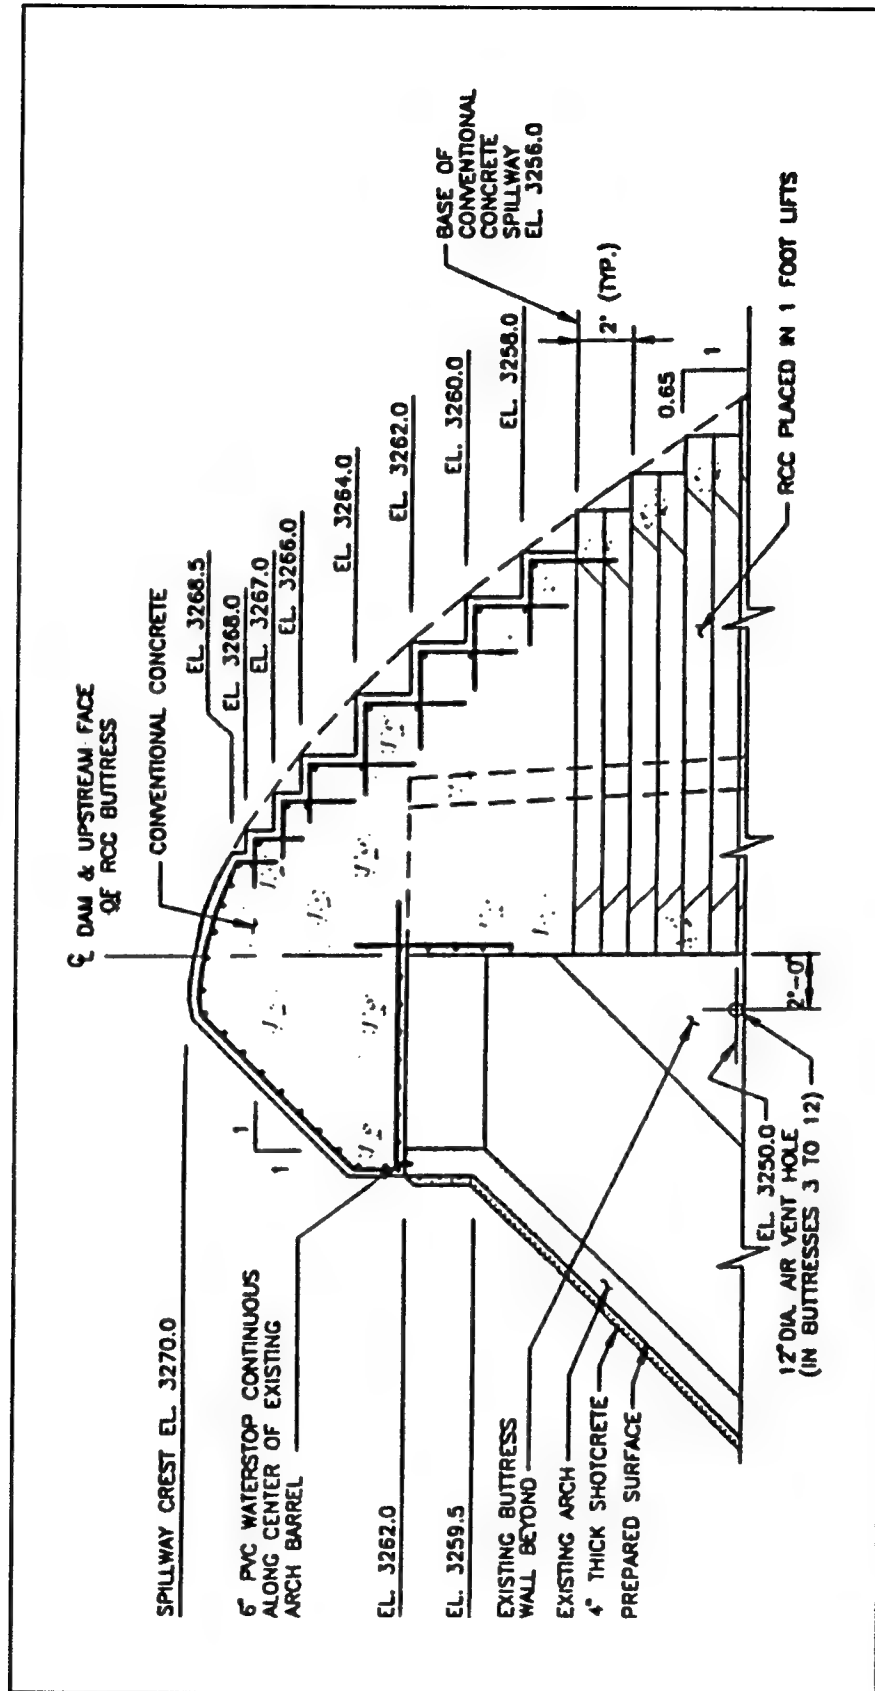
Figure 79. Spillway crest detail, Little Rock Dam (courtesy of Wong, Forrest, and Lo 1993, ASDSO). (Multiply feet by 0.3048 to obtain metres and inches by 25.4 to obtain millimetres)

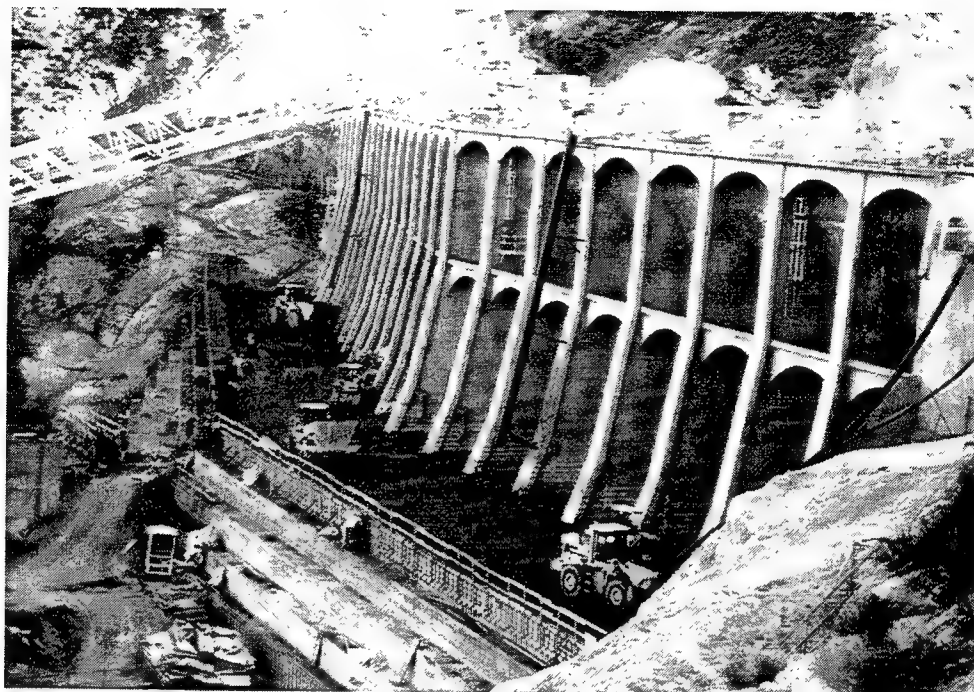
Aggregate and sound concrete were exposed on the downstream surfaces of the existing buttresses to increase bond with the RCC. A conveyor carried concrete up from a batch plant at the base to a reversible belt at the crest where it dropped down a 610-mm- (24-in.-) diam baffled chute of high-density polyethylene (Figure 80). Front-end loaders transported the RCC to the

Figure 80. Concrete conveyor and discharge pipes, Littlerock Dam

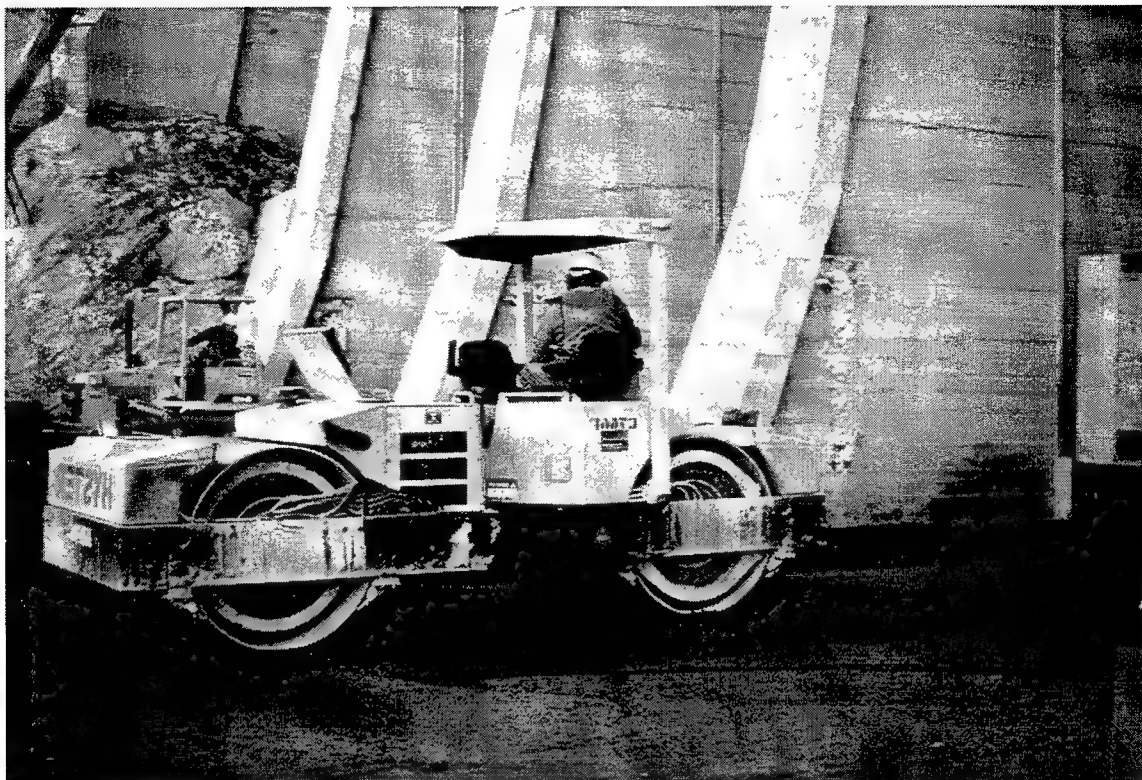
placement site where it was then spread with dozers into 305-mm- (12-in.-) thick lifts and compacted with vibratory rollers (Figure 81). Specified compaction was an average wet density of 99 percent of the density of the laboratory test cylinders; 97 percent was the minimum acceptable density. Prior to placement of the RCC, a layer of bedding mortar was spread on the foundation rock surface. It was also placed between lifts of RCC to provide positive tensile strength between successive lifts in the event of an earthquake.

Figure 81. Compacting RCC around the existing buttresses, Littlerock Dam

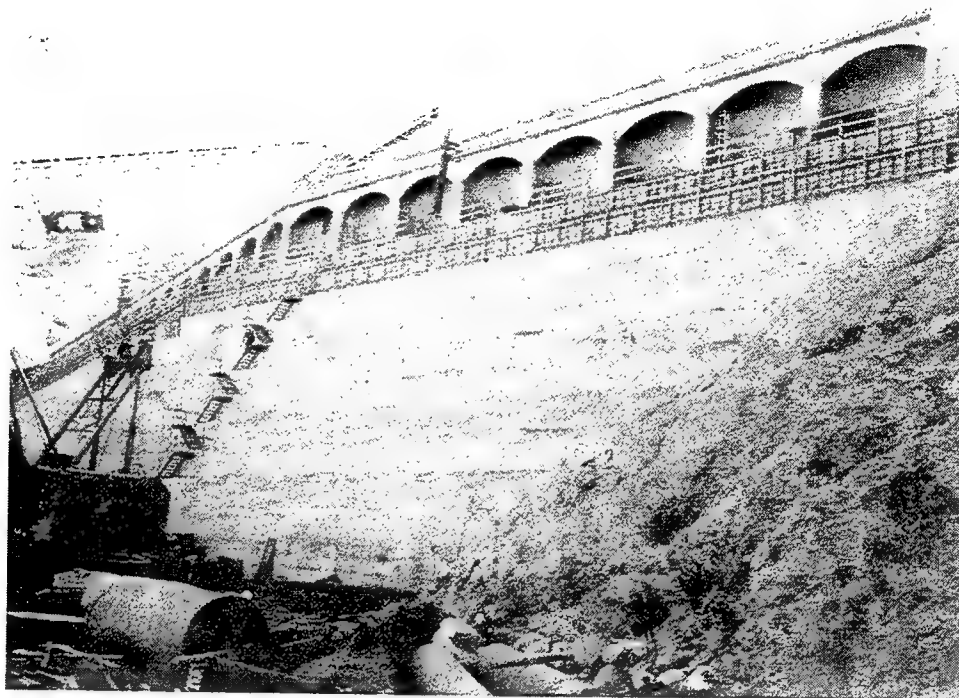
In an update following the earthquake in the Los Angeles area in January 1994, *ENR* (1994) reported that Littlerock Dam suffered no damage as a result of the earthquake even though the epicenter was only 56 km (35 miles) from the dam. Some dams in the area suffered limited damage, but at the Littlerock Dam project, work was not even interrupted (Figure 82). The completed rehabilitation is shown in Figure 83.

Figure 82. Partially completed rehabilitation of Littlerock Dam (courtesy of *ENR* 1994)

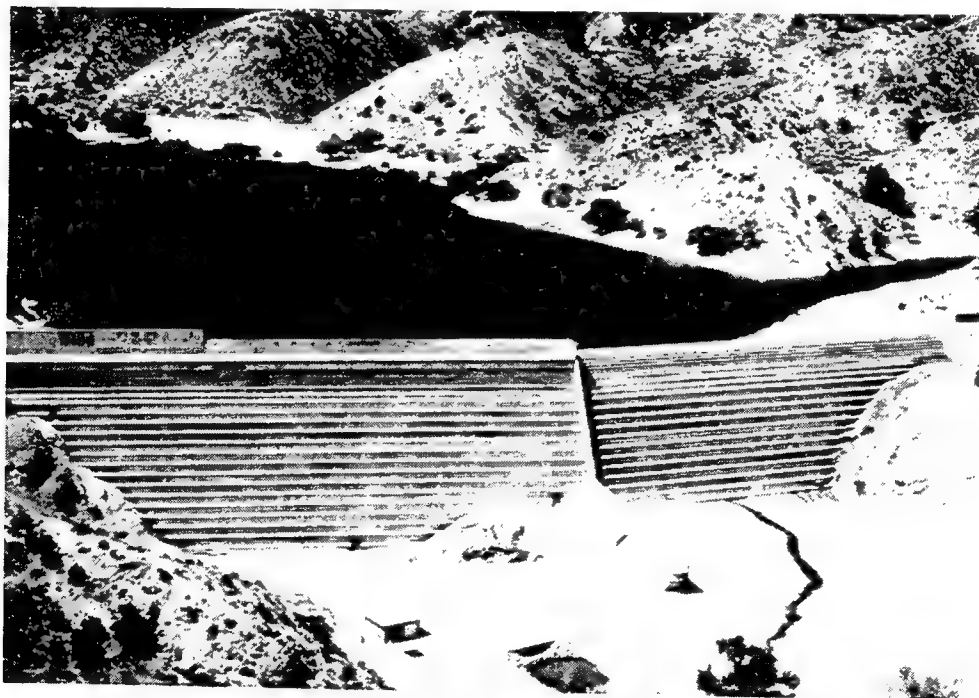
Figure 83. Downstream face of Littlerock Dam following rehabilitation
